INSPECTION REPORT

1.0 _____ *Property Address*

*123 W. New Home Street
Phoenix AZ.*

1.0 _____ *This two story home is apx . 3000
sq ft.*

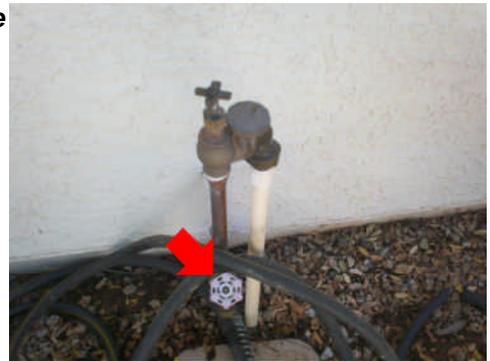
1.3 _____ The water supply main shut-off valve was outside on front of the home.

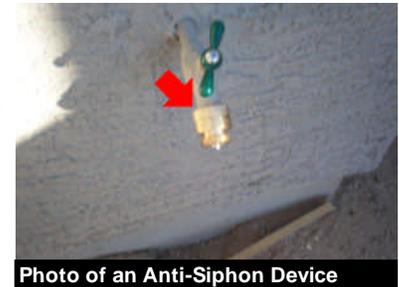
Photo of an Anti-Siphon Device

2.7 Hose Bibs **** An anti-siphon device is missing on the rear exterior hose bib.
These inexpensive safety devices are designed to protect the house water supply from contamination from bacteria in the water hose, or from something sprayed using the garden hose (such as an insecticide, weed killer, fertilizer, etc.)
This safety device that screws on the faucet, can be purchased at most hardware or plumbing stores for apx \$6- \$8.00
Correction Recommended: An anti-siphon device should be installed to improve the margin of health safety.
<http://www.essortment.com/plumbing-tips-anti-siphon-backflow-prevention-mean-12774.html>*

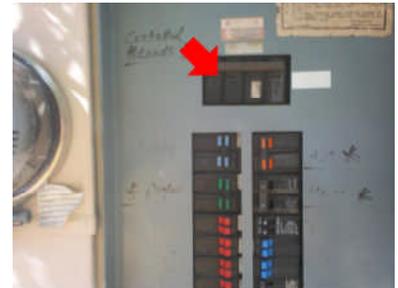
The main disconnect of the electrical system was a single throw, main breaker at top of the panel.

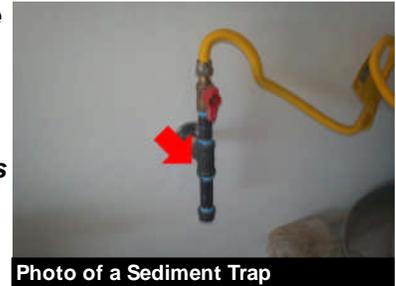
- 5.7 _____ **** A sediment trap was not installed on the gas line to the water heater. This may void the manufactures, or an extended warranty. A drip leg/sediment trap is currently required by all manufactures installation requirements, to prevent damage to the gas valve from moisture or debris in the gas lines.
Correction Recommended: A sediment trap should be installed to the manufactures installation specifications by a qualified plumbing contractor.*

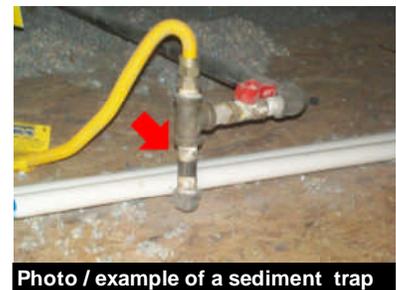
Photo / example of a sediment trap

Correction Recommended: When you have the furnace serviced before the next heating season, recommend having your heating contractor installing a "Sediment Trap" to the gas piping at the furnace.

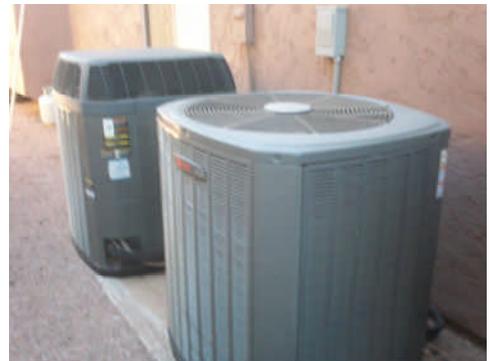
The exterior AC units were level and
raised above the ground.

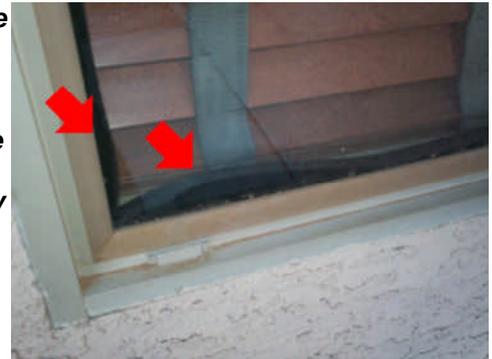
10.12 Thermopane Seal *** The window seal/ divider strips are not in place on the front entry and master bath windows
This will cause the seal between the two windows to fail and moisture between the two window panels.
Correction Recommended: The only way to correct this is by replacing the windows.*

*At time of the inspection the windows did not show any evidence of moisture between the windows.
Note: The seal between the two glass panels could fail anytime and may not be visible at the time of the inspection due to atmospheric conditions.*

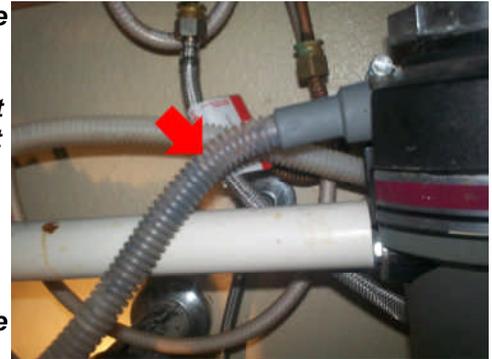
Photo of high loop

- 11.10 ****The dishwasher drain did not have the required air gap device or high loop in the drain line under the sink. The dishwasher will function without it, but this installation does not meet current standards. With out this device or a high loop, water from the kitchen drain sewer water can drain into the dishwasher. Correction Recommended. An air gap device, or a high loop should be provided to conform with current standards for health safety. A high loop can be provided by raising the drain line and securing the drain line to the to the bottom of the countertop.*

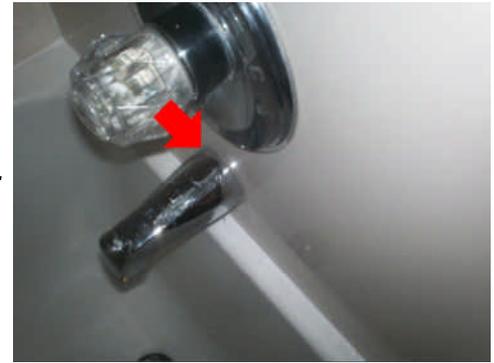
12.19 Tub Spouts

*The hall bath tub spout was not secured to the wall.
Correction Recommended: The tub spout should be properly secured and sealed to prevent water leakage and damage behind the shower wall.*

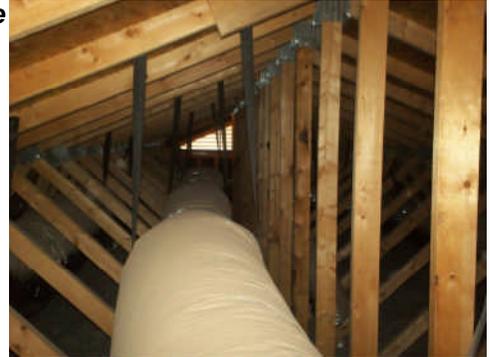
13.8 *The attic was entered and accessible areas [access with 30" or more] were viewed from within; Access Location... Master bedroom closet.*

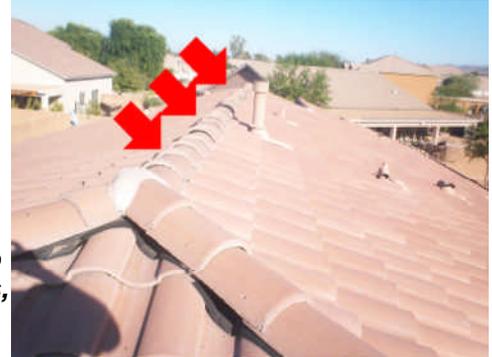
****There were several loose center ridge roof tiles.
Correction Recommended: A qualified roofing contractor should properly secure the tiles, and any other deficiencies found, should be repaired or replaced and or re-secured to manufactures specifications to prevent damage to the exposed underlayment materials, and to prevent water leaks.*

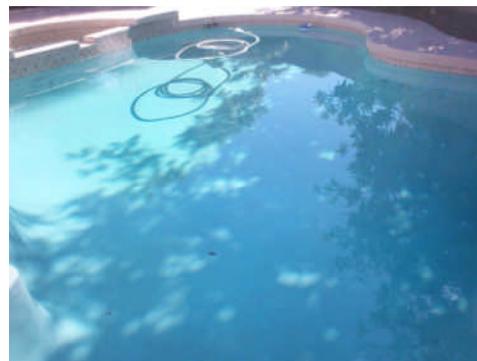
15.1 Type

The in-ground pool on this property was made of a spray applied concrete with an application of epoxied stone.

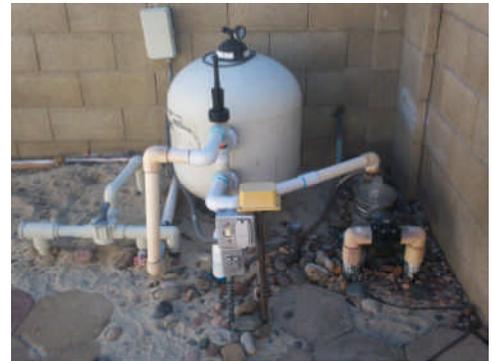
Filter Brand

15.5 _____ *The filter was a Hayward filter.*

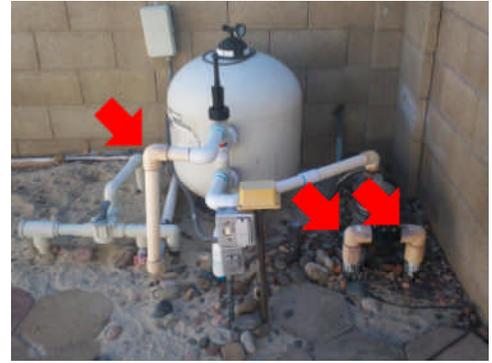
Visible Plumbing Line

- 15.9 Condition: *****Some of the plastic pool PVC piping was replaced and the piping is exposed to ultra violet sunlight damage.
Correction Recommended: The exposed plastic piping should be painted to protect it from UV damage.**

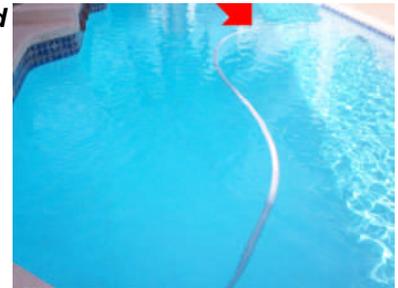
Pool Cleaning

- 15.11 **An above ground pool cleaner was provided for this pool.
The pool cleaner was functioning.**
